Roofing - Current Issues

Project reference: B171840/1 Project name: Great Gaddesden C of E VA School

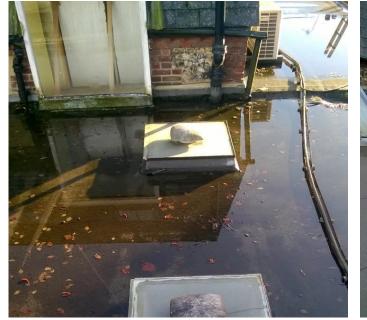
Roof B – Standing & Penetrating water & "Dormer" Window

- Roof A
 - Roof Decking & Surface replaced with similar at slight gradient
 - Window overlooking Churchyard to be reduced in size grey window frame
- Roof B
 - Roof Surface to be replaced with similar matching gradient from Courtyard
 - 2 x roof lights replaced with low profile domed rooflights
 - 1970's Dormer window removed roofline and wall re-instated to original.
 - Sloped Glazed area removed (infill with new roof surface and replacement (grey powder-coat) roof lantern.
 - Glazed side screen (to Courtyard) replaced with matching Grey Powdercoated glazed screed.
- Roof C
 - Roof surface replaced with centre ridge pitch with shallow gradient
 - 1 x roof light replaced with low profile domed rooflight

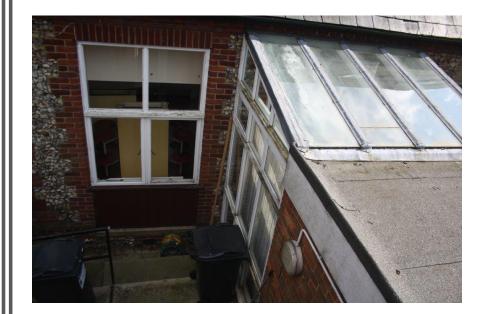
Roof B- Glazed roof over Reading Area

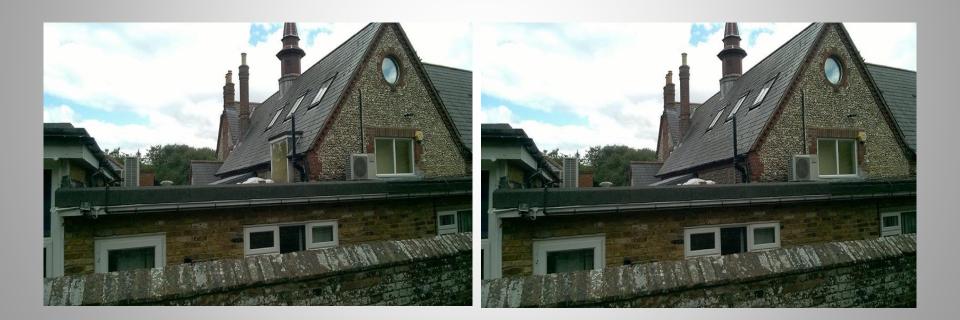
Disused Dormer Window
